# Access Compliance Report Public Rights-of-Way (Curb Ramps)

Main Street: ARTISAN\_ST Cross Street: BENJAMIN\_DR Location: N

ADA ID: RPRK211020163111 Ramp Type: Type 1 - Perpendicular Diagonal Initial Pass/Fail: Pass Overall Compliance: No Severity Score: 20

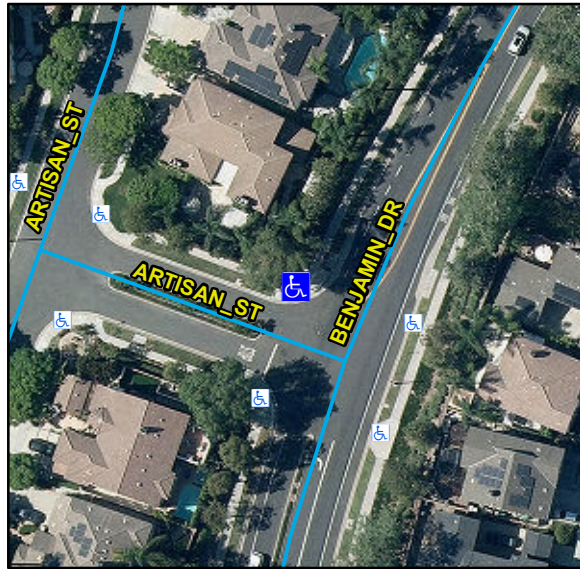
| Compliance | Description | Data | Compliance | Description | Data |
|---|---|---|---|---|---|
| No | Landing Run Slope (%) | 2.6 | N/A | Flare Traversable RT | Yes |
| Yes | Landing Cross Slope (%) | 0.9 | No | DWS Provided | No |
| Yes | Gutter Ponding | No | No | Curb Slope | 10.9 |
| No | Gutter Run Slope (%) | 5.3 | | Road Cross Slope (%) | 1.4 |

Remove & Replace Curb Ramp With Two New Directional Ramps or Equivalent. Remove & Replace Gutter.
