# Access Compliance Report Public Rights-of-Way (Curb Ramps)

| Main Street: ARTISAN_ST | | Cross Street: ARTISAN_ST | | Location: | S |
| ADA ID: RPRK211020163734 | Ramp Type: Type 4 - Parallel | Initial Pass/Fail: Fail | Overall Compliance: No | Severity Score: | 2 |

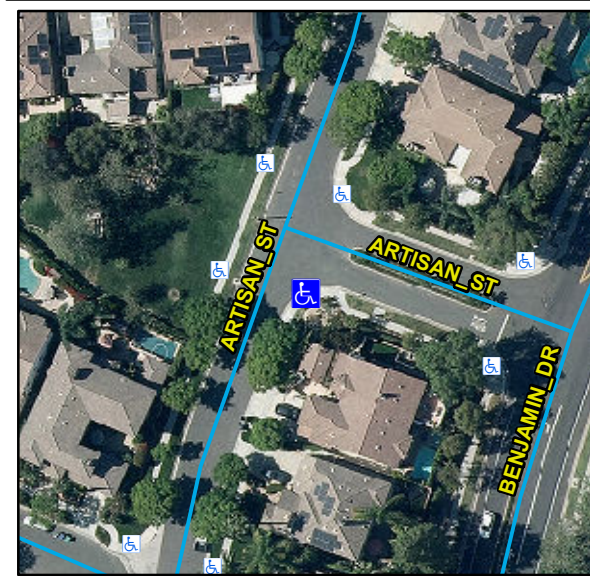
| Compliance | Description | Data | Compliance | Description | Data |
|---|---|---|---|---|---|
| No | Ramp Cross Slope LT (%) | 3.9 | No | Ramp Cross Slope RT (%) | 2.3 |

**Remove & Replace Curb Ramp With Two New Directional Ramps or Equivalent.**

**R204.3, R304.5.3, STD 1115**

Total Cost: \$ 4000
