# Access Compliance Report Public Rights-of-Way (Curb Ramps)

Main Street: ARTISAN\_ST Cross Street: WINSLOW\_ST Location: E

ADA ID: RPRK211020164139 Ramp Type: Type 4 - Parallel Initial Pass/Fail: Fail Overall Compliance: No Severity Score: 30

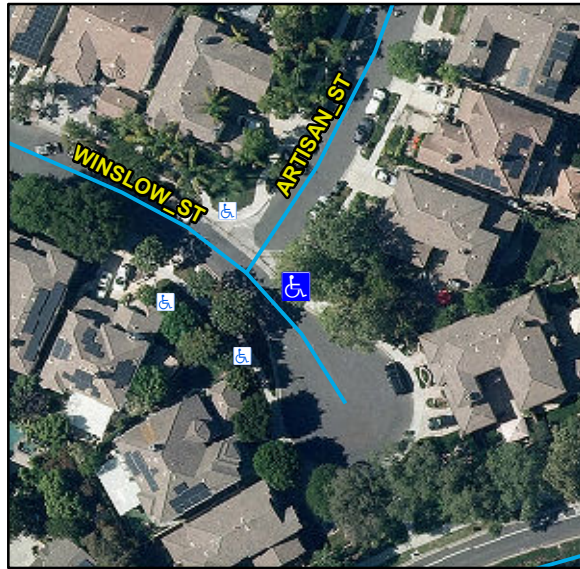
| Compliance | Description | Data | Compliance | Description | Data |
|---|---|---|---|---|---|
| Yes | Ramp Run Slope LT (%) | 6 | No | Ramp Run Slope RT (%) | 12.3 |

**Remove & Replace Curb Ramp With Two New Directional Ramps or Equivalent.**

**R204.3, R304.3.2, STD 1115**
