# Access Compliance Report Public Rights-of-Way (Curb Ramps)

Main Street: WINSLOW\_ST Cross Street: ARTISAN\_ST Location: N

ADA ID: RPRK211020164353 Ramp Type: Type 4 - Parallel Initial Pass/Fail: Fail Overall Compliance: No Severity Score: 2

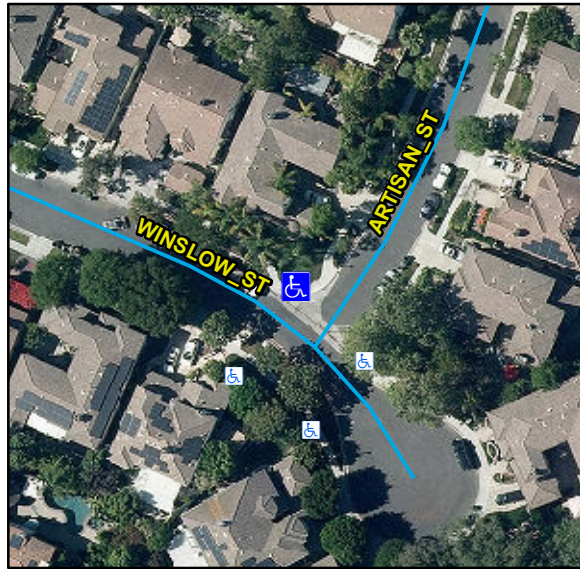
| Compliance | Description | Data | Compliance | Description | Data |
|---|---|---|---|---|---|
| N/A | Ramp Length LT (in) | 119 | N/A | Ramp Length RT (in) | 114 |
| Yes | Ramp Width LT (in) | 53 | Yes | Ramp Width RT (in) | 52 |
| Yes | Ramp Run Slope LT (%) | 6.6 | Yes | Ramp Run Slope RT (%) | 5.6 |
| No | Ramp Cross Slope LT (%) | 2.9 | No | Ramp Cross Slope RT (%) | 2.2 |

**Remove & Replace Curb Ramp With Two New Directional Ramps or Equivalent.**

**R204.3, R304.5.3, STD 1115**

Total Cost: \$ 4000
