Access Compliance Report Public Rights-of-Way (Curb Ramps)

Main Street: ARTISAN_ST **Cross Street:** WYETH_ST **Location:** W

ADA ID: RPRK211020164611 **Ramp Type:** Type 4 - Parallel **Initial Pass/Fail:** Fail **Overall Compliance:** No **Severity Score:** 15

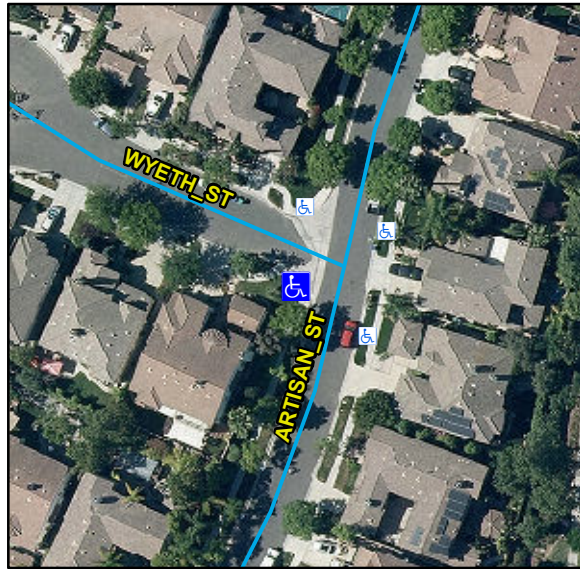
Compliance	Description	Data	Compliance	Description	Data
N/A	Ramp Length LT (in)	108	N/A	Ramp Length RT (in)	114
Yes	Ramp Width LT (in)	53	Yes	Ramp Width RT (in)	54
Yes	Ramp Run Slope LT (%)	5.7	No	Ramp Run Slope RT (%)	10.1
Yes	Ramp Cross Slope LT (%)	0.9	Yes	Ramp Cross Slope RT (%)	0.2
N/A	Landing Present	N/A	N/A	DWS Provided	N/A
N/A	Landing Length (in)	N/A	N/A	DWS Contrast	N/A
N/A	Landing Width (in)	N/A	N/A	DWS Length (in)	N/A
N/A	Landing Run Slope (%)	N/A	N/A	DWS Full Width	N/A
N/A	Landing Cross Slope (%)	N/A		DWS Offset Type	N/A
N/A	Landing Movement Obstructed?	N/A	N/A	DWS Offset Left (in)	N/A
	Landing Movement Type	N/A	N/A	DWS Offset Right (in)	N/A
N/A	Landing Shared	N/A			
N/A	Clear Space	Yes			
N/A	Clear Space To Crosswalk (in)	N/A			
N/A	Marked Crosswalk 1	No	N/A	Marked Crosswalk 2	No
	Crossing 1 Direction	SE		Crossing 2 Direction	NE
N/A	Marked Crosswalk 1 Width (in)	N/A		Marked Crosswalk 2 Width (in)	N/A

N/A	Ramp Inside Crosswalk 1	N/A	N/A	Ramp Inside Crosswalk 2	N/A
	Crossing 1 Slope (%)	2.3		Crossing 2 Slope (%)	0.4
	Crossing 1 Cross Slope (%)	1.4		Crossing 2 Cross Slope (%)	1
N/A	Gutter Ponding	N/A	N/A	Curb Slope	2.5
Yes	Gutter Lip Height (in)	0		Road Run Slope (%)	1.6
N/A	Gutter Run Slope (%)	N/A		Road Cross Slope (%)	0.9
N/A	Gutter Cross Slope (%)	N/A	No	Perpendicular Joint Present	No
Yes	Overall Surface Condition	Acceptable		Spandrel Present?	Yes
	Cross Gutter Present?	Yes		Replace Spandrel?	No
	Replace Cross Gutter?	No

Possible Solutions:
Remove & Replace Curb Ramp With Two New Directional Ramps or Equivalent.

OC Std/PROW:
 R204.3, R304.3.2, STD 1115

Total Cost: \$ 4000
