# Access Compliance Report Public Rights-of-Way (Curb Ramps)

Main Street: WYETH\_ST Cross Street: ARTISAN\_ST Location: N

ADA ID: RPRK211020164842 Ramp Type: Type 4 - Parallel Initial Pass/Fail: Fail Overall Compliance: No Severity Score: 15

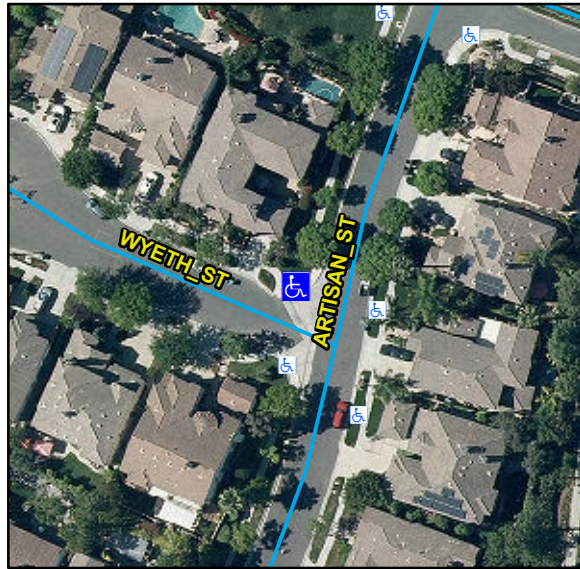
| Compliance | Description | Data | Compliance | Description | Data |
|---|---|---|---|---|---|
| Yes | Ramp Run Slope LT (%) | 3.9 | No | Ramp Run Slope RT (%) | 10.7 |

**Remove & Replace Curb Ramp With Two New Directional Ramps or Equivalent.**

**R204.3, R304.3.2, STD 1115**
