# Access Compliance Report Public Rights-of-Way (Curb Ramps)

Main Street: THALIA\_ST Cross Street: ARTISAN\_ST Location: NW

ADA ID: RPRK211020165310 Ramp Type: Type 1 - Perpendicular Initial Pass/Fail: Fail Overall Compliance: No Severity Score: 2

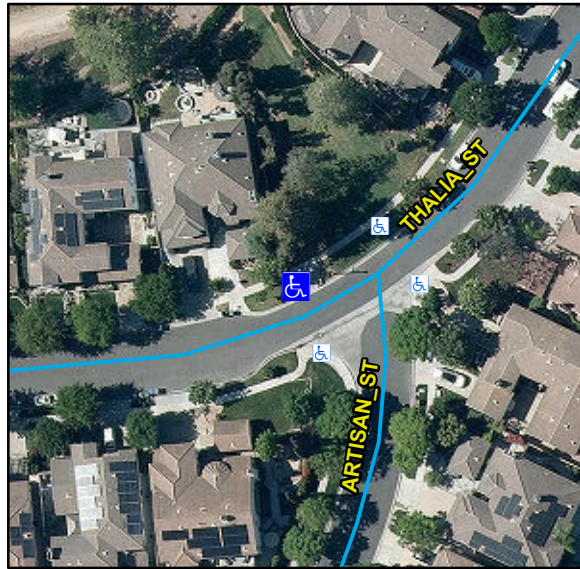
R204.3, R304.5.3, STD 1115

| Compliance | Description | Data | Compliance | Description | Data |
|---|---|---|---|---|---|
| No | Ramp Cross Slope (%) | 2.1 | N/A | Flare Traversable LT | N/A |

Remove & Replace Entire Ramp.
