# Access Compliance Report Public Rights-of-Way (Curb Ramps)

| Main Street: THALIA_ST | | Cross Street: ARTISAN_ST | | Location: | SE |
| ADA ID: RPRK211020165413 | Ramp Type: Type 4 - Parallel | Initial Pass/Fail: Fail | Overall Compliance: No | Severity Score: | 16 |

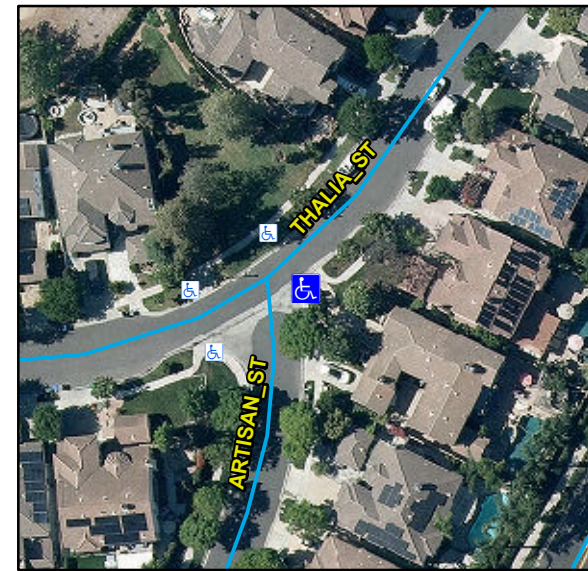
**R204.3, R304.3.2, R304.5.3, STD 1115**

| Compliance | Description | Data | Compliance | Description | Data |
|---|---|---|---|---|---|
| No | Ramp Run Slope LT (%) | 10.5 | Yes | Ramp Run Slope RT (%) | 1.1 |
| No | Ramp Cross Slope LT (%) | 2.3 | No | Ramp Cross Slope RT (%) | 4.4 |

**Remove & Replace Curb Ramp With Two New Directional Ramps or Equivalent.**

Total Cost: \$ 4000
