# Access Compliance Report Public Rights-of-Way (Curb Ramps)

Main Street: ARTISAN\_ST Cross Street: THALIA\_ST Location: SW

ADA ID: RPRK211020165646 Ramp Type: Type 4 - Parallel Initial Pass/Fail: Fail Overall Compliance: No Severity Score: 15

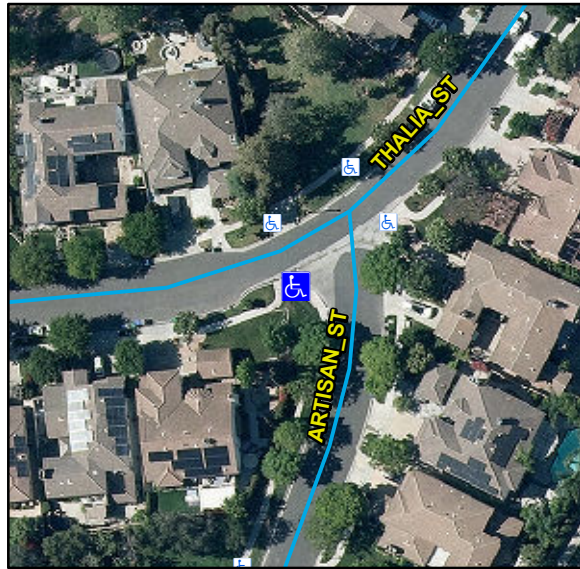
| Compliance | Description | Data | Compliance | Description | Data |
|---|---|---|---|---|---|
| No | Ramp Run Slope LT (%) | 10.7 | Yes | Ramp Run Slope RT (%) | 1.9 |

Remove & Replace Curb Ramp With Two New Directional Ramps or Equivalent.

R204.3, R304.3.2, STD 1115
