# Access Compliance Report Public Rights-of-Way (Curb Ramps)

Main Street: O\_NEILL\_DR Cross Street: BENJAMIN\_DR Location: SW

ADA ID: RPRK211020170310 Ramp Type: Type 1 - Perpendicular Initial Pass/Fail: Fail Overall Compliance: No Severity Score: 2

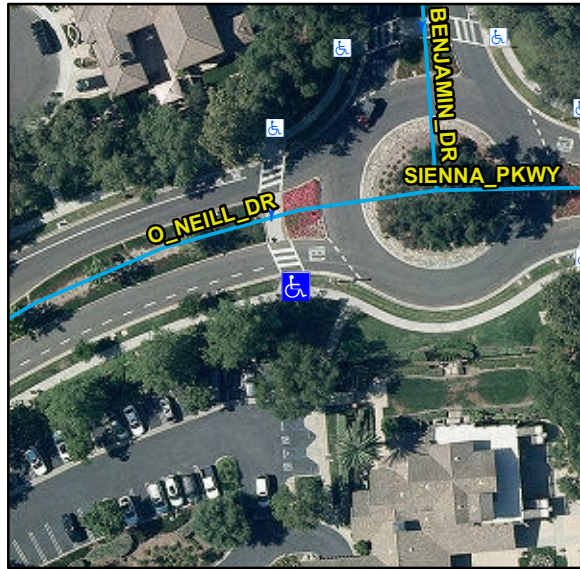
| Compliance | Description | Data | Compliance | Description | Data |
|---|---|---|---|---|---|
| No | Ramp Cross Slope (%) | 3 | N/A | Flare Traversable LT | N/A |
| N/A | Gutter Ponding | N/A | No | Curb Slope | 10.2 |

Remove & Replace Entire Ramp.
