# Access Compliance Report Public Rights-of-Way (Curb Ramps)

Main Street: O\_NEILL\_DR Cross Street: BENJAMIN\_DR Location: NW

ADA ID: RPRK211020170451 Ramp Type: Type 1 - Perpendicular Initial Pass/Fail: Pass Overall Compliance: No Severity Score: 25

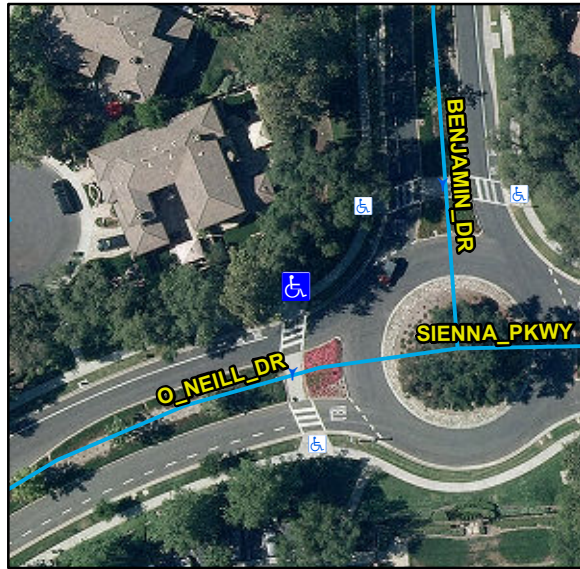
| Compliance | Description | Data | Compliance | Description | Data |
|---|---|---|---|---|---|
| No | Landing Cross Slope (%) | N/A | No | DWS Provided | No |
| Yes | Gutter Ponding | No | No | Curb Slope | 7.5 |
| No | Gutter Run Slope (%) | 9.1 | | Road Cross Slope (%) | N/A |

Remove & Replace Entire Ramp. Remove & Replace Gutter.

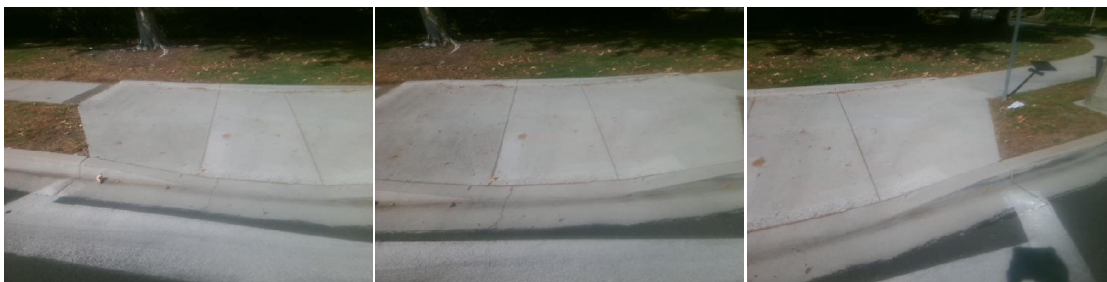
| Compliance | Description | Data | Compliance | Description | Data |
|---|---|---|---|---|---|
| Yes | Overall Surface Condition: Acceptable | | Yes | Perp Joint Present | Yes |
