# Access Compliance Report Public Rights-of-Way (Curb Ramps)

Main Street: BENJAMIN\_DR Cross Street: O\_NEILL\_DR Location: NW

ADA ID: RPRK211020170720 Ramp Type: Type 1 - Perpendicular Initial Pass/Fail: Pass Overall Compliance: No Severity Score: 25

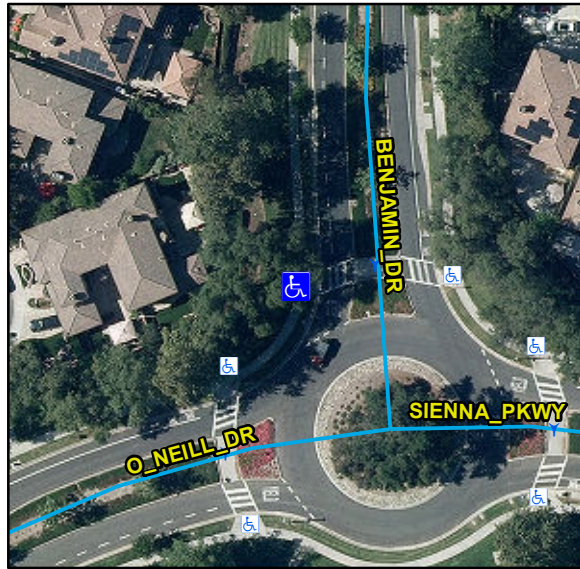
| Compliance | Description | Data | Compliance | Description | Data |
|---|---|---|---|---|---|
| No | Landing Width (in) | N/A | N/A | Flare Slope RT (%) | 10.1 |
| No | Landing Run Slope (%) | N/A | N/A | Flare Traversable RT | No |
| No | Landing Cross Slope (%) | N/A | No | DWS Provided | No |
| No | Gutter Run Slope (%) | 8.3 | | Road Cross Slope (%) | N/A |

Remove & Replace Entire Ramp. Remove & Replace Gutter.
