# Access Compliance Report Public Rights-of-Way (Curb Ramps)

Main Street: BENJAMIN\_DR Cross Street: SIENNA\_PKWY Location: NE

ADA ID: RPRK211020170941 Ramp Type: Type 1 - Perpendicular Initial Pass/Fail: Fail Overall Compliance: No Severity Score: 2

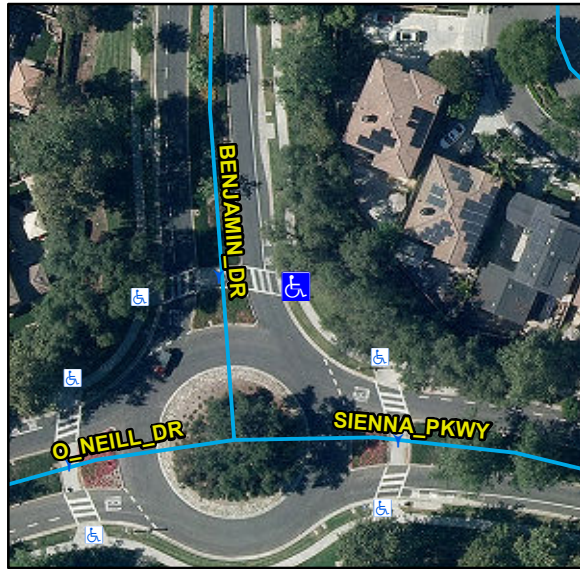
| Compliance | Description | Data | Compliance | Description | Data |
|---|---|---|---|---|---|
| No | Ramp Cross Slope (%) | 2.4 | N/A | Flare Traversable LT | N/A |
| N/A | Gutter Ponding | N/A | No | Curb Slope | 8.6 |

Remove & Replace Entire Ramp.

R304.2.2, R304.5.3, STD 1115
