# Access Compliance Report Public Rights-of-Way (Curb Ramps)

| Main Street: SIENNA_PKWY | | Cross Street: BENJAMIN_DR | | Location: | E |
| ADA ID: RPRK211020171149 | Ramp Type: Type 1 - Perpendicular | Initial Pass/Fail: Pass | Overall Compliance: No | Severity Score: | 26 |

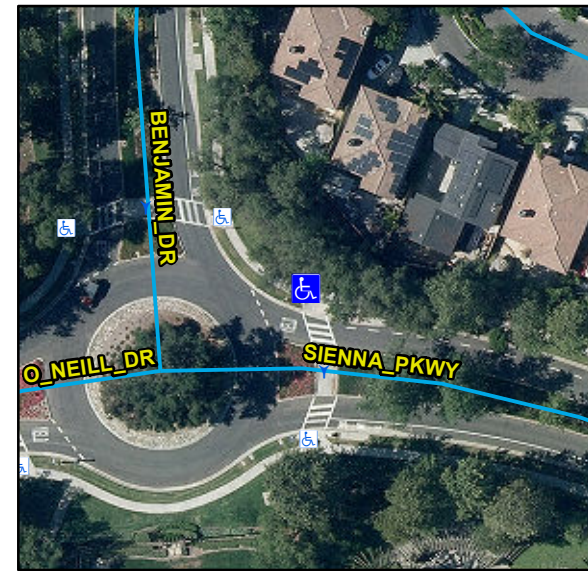
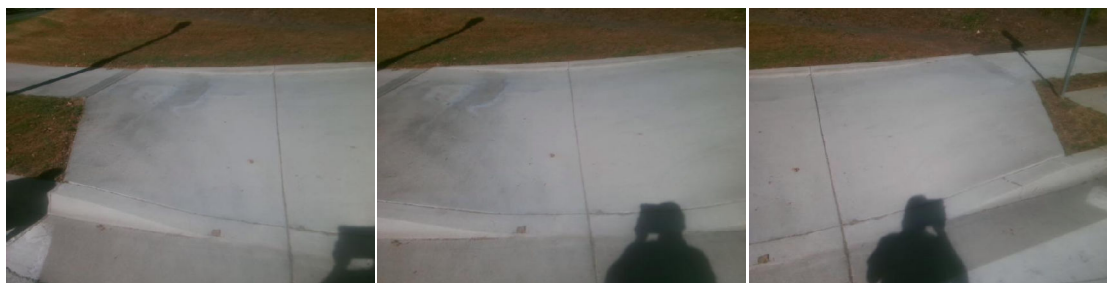
| Compliance | Description | Data | Compliance | Description | Data |
|---|---|---|---|---|---|
| No | Landing Width (in) | N/A | N/A | Flare Slope RT (%) | 17.1 |
| No | Landing Run Slope (%) | N/A | N/A | Flare Traversable RT | No |
| No | Landing Cross Slope (%) | N/A | No | DWS Provided | No |
| No | Gutter Run Slope (%) | 7.5 | | Road Cross Slope (%) | N/A |
| No | Gutter Cross Slope (%) | 3.1 | | | |

Remove & Replace Entire Ramp. Remove & Replace Gutter.
