Access Compliance Report Public Rights-of-Way (Curb Ramps)

Main Street: SIENNA_PKWY **Cross Street:** BENJAMIN_DR **Location:** E

ADA ID: RPRK211020171400 **Ramp Type:** Type 1 - Perpendicular **Initial Pass/Fail:** Pass **Overall Compliance:** No **Severity Score:** 25

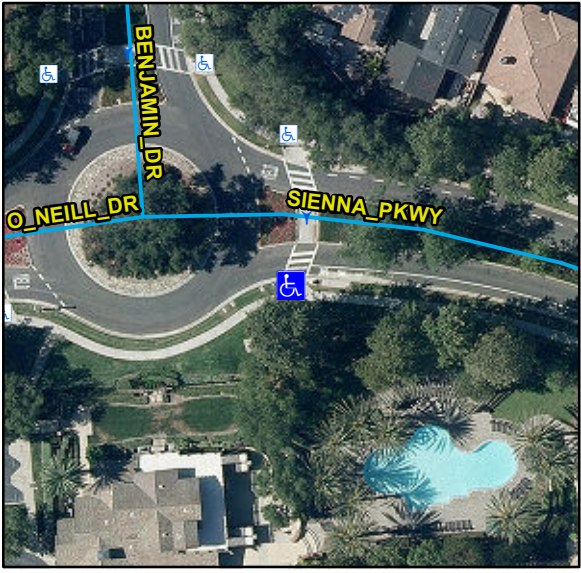
Compliance	Description	Data	Compliance	Description	Data
N/A	Ramp Length (in)	137	N/A	Flare Type LT	
Yes	Ramp Width (in)	60			Sloped
Yes	Ramp Run Slope (%)	2.9	N/A	Flare Slope LT (%)	8.9
Yes	Ramp Cross Slope (%)	0.4	N/A	Flare Traversable LT	No
N/A	Landing Present	No	N/A	Flare Type RT	
N/A	Landing Length (in)	N/A			Sloped
No	Landing Width (in)	N/A	N/A	Flare Slope RT (%)	12
No	Landing Run Slope (%)	N/A	N/A	Flare Traversable RT	No
No	Landing Cross Slope (%)	N/A	No	DWS Provided	No
N/A	Landing Movement Obstructed?	Yes	N/A	DWS Contrast	N/A
	Landing Movement Type	Curb	N/A	DWS Length (in)	N/A
N/A	Landing Shared	N/A	N/A	DWS Full Width	N/A
N/A	Clear Space	N/A	N/A	DWS Offset Left (in)	N/A
N/A	Clear Space To Crosswalk (in)	N/A	N/A	DWS Offset Right (in)	N/A
N/A	Marked Crosswalk 1	Yes	N/A	Marked Crosswalk 2	N/A
	Crossing 1 Direction	N		Crossing 2 Direction	N/A
	Marked Crosswalk 1 Width (in)	144		Marked Crosswalk 2 Width (in)	N/A

Yes	Ramp Inside Crosswalk 1	Yes	Yes	Ramp Inside Crosswalk 2	N/A
	Crossing 1 Slope (%)	1.9		Crossing 2 Slope (%)	N/A
	Crossing 1 Cross Slope (%)	0.5		Crossing 2 Cross Slope (%)	N/A
Yes	Gutter Ponding	No	No	Curb Slope	13.9
Yes	Gutter Lip Height (in)	0		Road Run Slope (%)	N/A
No	Gutter Run Slope (%)	8.5		Road Cross Slope (%)	N/A
Yes	Gutter Cross Slope (%)	0.5			
Yes	Overall Surface Condition:	Acceptable	No	Perp Joint Present	No
	Cross Gutter Present?	No		Spandrel Present?	No
	Replace Cross Gutter?	N/A		Replace Spandrel?	N/A

Possible Solutions:
Remove & Replace Entire Ramp. Remove & Replace Gutter.
