# Access Compliance Report Public Rights-of-Way (Curb Ramps)

Main Street: WALDEN\_ST Cross Street: SIENNA\_PKWY Location: NW

ADA ID: RPRK211020172222 Ramp Type: Type 1 - Perpendicular Diagonal Initial Pass/Fail: Fail Overall Compliance: No Severity Score: 15

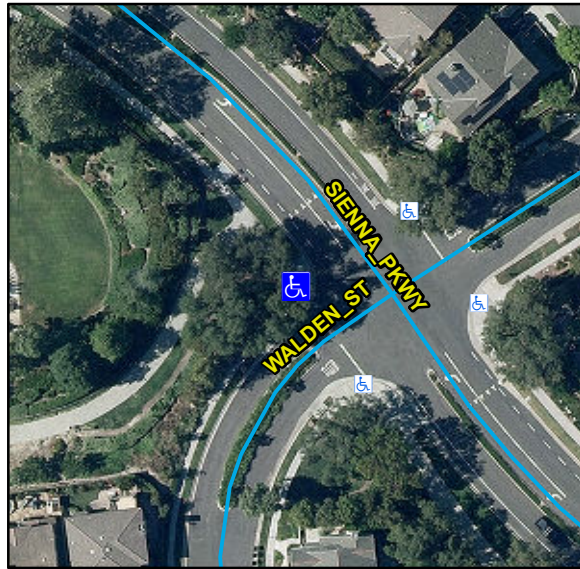
| Compliance | Description | Data | Compliance | Description | Data |
|---|---|---|---|---|---|
| No | Ramp Run Slope (%) | 8.9 | N/A | Flare Slope LT (%) | N/A |

**Remove & Replace Curb Ramp With Two New Directional Ramps or Equivalent. Restripe Crosswalk.**
