# Access Compliance Report Public Rights-of-Way (Curb Ramps)

Main Street: BRAMFORD\_RD Cross Street: WALDEN\_ST Location: NW

ADA ID: RPRK211020172942 Ramp Type: Type 4 - Parallel Initial Pass/Fail: Fail Overall Compliance: No Severity Score: 16

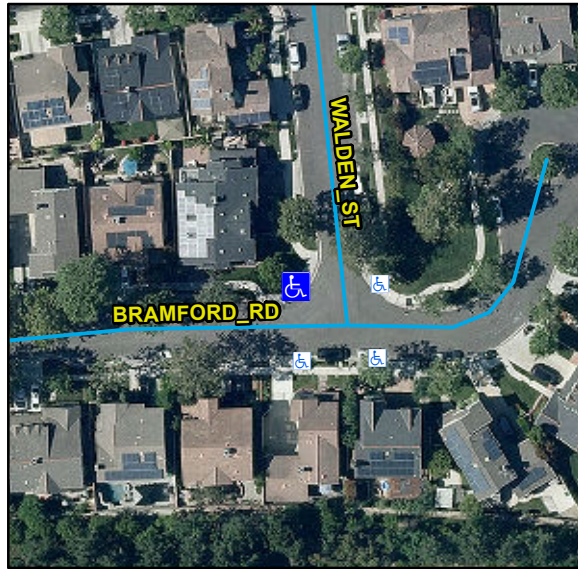
| Compliance | Description | Data | Compliance | Description | Data |
|---|---|---|---|---|---|
| Yes | Ramp Run Slope LT (%) | 0.8 | No | Ramp Run Slope RT (%) | 8.8 |
| No | Ramp Cross Slope LT (%) | 4.1 | Yes | Ramp Cross Slope RT (%) | 0.8 |
| N/A | Gutter Cross Slope (%) | N/A | No | Perpendicular Joint Present | No |

**Remove & Replace Curb Ramp With Two New Directional Ramps or Equivalent.**

**R204.3, R304.5.3, R304.3.2, STD 1115**
