# Access Compliance Report Public Rights-of-Way (Curb Ramps)

Main Street: WALDEN\_ST Cross Street: BRAMFORD\_RD Location: NE

ADA ID: RPRK211020173254 Ramp Type: Type 4 - Parallel Initial Pass/Fail: Pass Overall Compliance: No Severity Score: 25

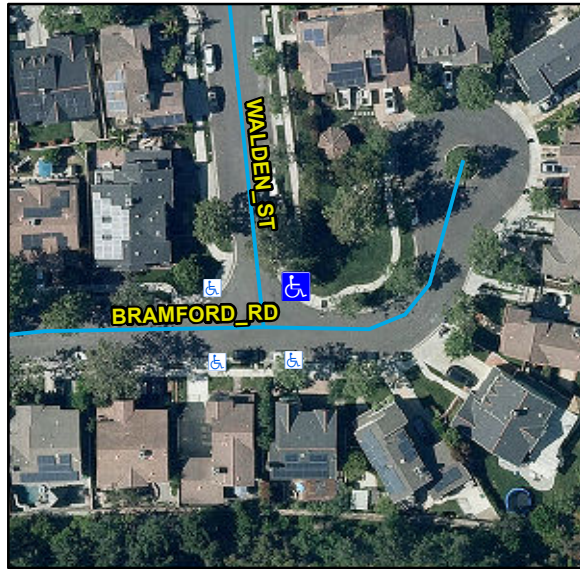
| Compliance | Description | Data | Compliance | Description | Data |
|---|---|---|---|---|---|
| N/A | Landing Present | No | No | DWS Provided | No |
| No | Landing Width (in) | N/A | N/A | DWS Length (in) | N/A |
| No | Landing Run Slope (%) | N/A | N/A | DWS Full Width | N/A |
| No | Landing Cross Slope (%) | N/A | | DWS Offset Type | N/A |
| Yes | Gutter Ponding | No | No | Curb Slope | 13.7 |
| No | Gutter Run Slope (%) | 5.7 | | Road Cross Slope (%) | 2.1 |

Remove & Replace Curb Ramp With Two New Directional Ramps or Equivalent. Remove & Replace Gutter.
