# Access Compliance Report Public Rights-of-Way (Curb Ramps)

Main Street: SIENNA\_PKWY Cross Street: WALDEN\_ST Location: SW

ADA ID: RPRK211020173614 Ramp Type: Type 1 - Perpendicular Diagonal Initial Pass/Fail: Fail Overall Compliance: No Severity Score: 16

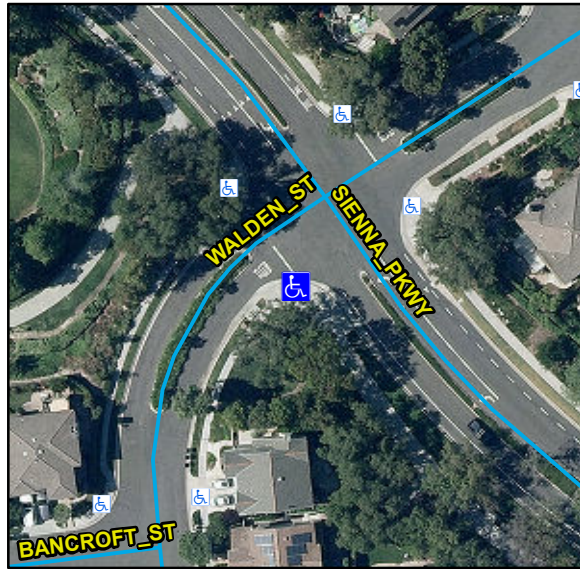
| Compliance | Description | Data | Compliance | Description | Data |
|---|---|---|---|---|---|
| No | Ramp Run Slope (%) | 8.8 | N/A | Flare Slope LT (%) | N/A |
| No | Ramp Cross Slope (%) | 4 | N/A | Flare Traversable LT | N/A |

Remove & Replace Curb Ramp With Two New Directional Ramps or Equivalent.

R304.2.2, R204.3, R304.5.3, STD 1115
