# Access Compliance Report Public Rights-of-Way (Curb Ramps)

Main Street: WALDEN\_ST Cross Street: SIENNA\_PKWY Location: E

ADA ID: RPRK211020173818 Ramp Type: Type 1 - Perpendicular Diagonal Initial Pass/Fail: Pass Overall Compliance: No Severity Score: 24

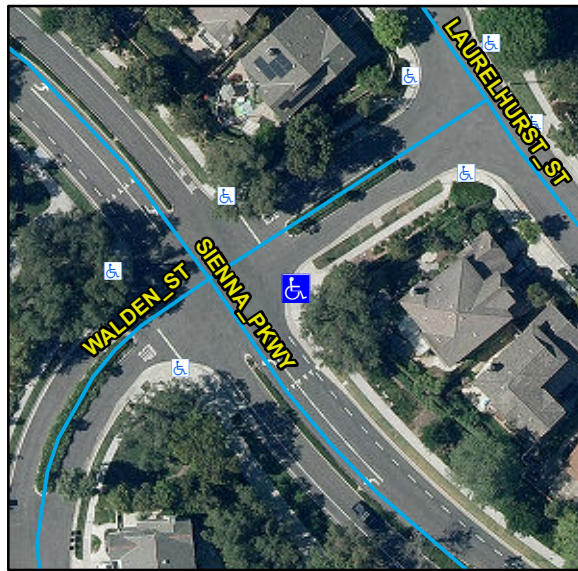
| Compliance | Description | Data | Compliance | Description | Data |
|---|---|---|---|---|---|
| No | Landing Run Slope (%) | 5.1 | N/A | Flare Traversable RT | Yes |
| No | Landing Cross Slope (%) | 3.6 | No | DWS Provided | No |
| Yes | Gutter Ponding | No | No | Curb Slope | 9.3 |
| No | Gutter Run Slope (%) | 8 | | Road Cross Slope (%) | 2 |
| No | Gutter Cross Slope (%) | 4.3 | | | |

Remove & Replace Curb Ramp With Two New Directional Ramps or Equivalent. Remove & Replace Gutter.
