# Access Compliance Report Public Rights-of-Way (Curb Ramps)

**Main Street:** SIENNA\_PKWY      **Cross Street:** WALDEN\_ST      **Location:** NE

**ADA ID:** RPRK211020174128      **Ramp Type:** Type 1 - Perpendicular Diagonal Initial Pass/Fail: Fail      **Overall Compliance:** No      **Severity Score:** 2

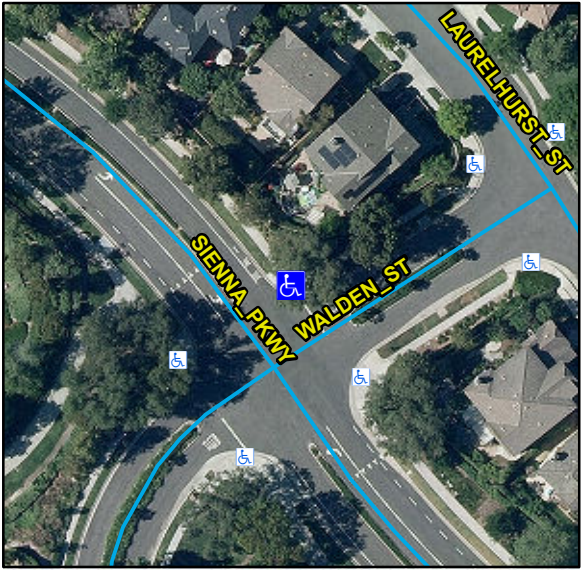
Compliance	Description	Data	Compliance	Description	Data
N/A	Ramp Length (in)	128	N/A	Flare Type LT	
Yes	Ramp Width (in)	48			N/A
Yes	Ramp Run Slope (%)	5.9	N/A	Flare Slope LT (%)	N/A
No	Ramp Cross Slope (%)	2.5	N/A	Flare Traversable LT	N/A
N/A	Landing Present	N/A	N/A	Flare Type RT	
N/A	Landing Length (in)	N/A			N/A
N/A	Landing Width (in)	N/A	N/A	Flare Slope RT (%)	N/A
N/A	Landing Run Slope (%)	N/A	N/A	Flare Traversable RT	N/A
N/A	Landing Cross Slope (%)	N/A	N/A	DWS Provided	N/A
N/A	Landing Movement Obstructed?	N/A	N/A	DWS Contrast	N/A
	Landing Movement Type	N/A	N/A	DWS Length (in)	N/A
N/A	Landing Shared	N/A	N/A	DWS Full Width	N/A
N/A	Clear Space	Yes	N/A	DWS Offset Left (in)	N/A
N/A	Clear Space To Crosswalk (in)	N/A	N/A	DWS Offset Right (in)	N/A
N/A	Marked Crosswalk 1	No	N/A	Marked Crosswalk 2	No
	Crossing 1 Direction	W		Crossing 2 Direction	S
	Marked Crosswalk 1 Width (in)	N/A		Marked Crosswalk 2 Width (in)	N/A

N/A	Ramp Inside Crosswalk 1	N/A	Yes	Ramp Inside Crosswalk 2	N/A
	Crossing 1 Slope (%)	3		Crossing 2 Slope (%)	2.4
	Crossing 1 Cross Slope (%)	3.1		Crossing 2 Cross Slope (%)	3.6
N/A	Gutter Ponding	N/A	No	Curb Slope	6.5
Yes	Gutter Lip Height (in)	0		Road Run Slope (%)	2.8
N/A	Gutter Run Slope (%)	N/A		Road Cross Slope (%)	1.2
N/A	Gutter Cross Slope (%)	N/A			
Yes	Overall Surface Condition: <b>Acceptable</b>		No	Perp Joint Present	No
	Cross Gutter Present?	No		Spandrel Present?	No
	Replace Cross Gutter?	N/A		Replace Spandrel?	N/A

**Possible Solutions:**  
**Remove & Replace Curb Ramp With Two New Directional Ramps or Equivalent.**

**OC Std/PROW:**  
 R304.2.2, R204.3, R304.5.3, STD 1115
