# Access Compliance Report Public Rights-of-Way (Curb Ramps)

ADA ID: RPRK211020175209 Ramp Type: Type 4 - Parallel Initial Pass/Fail: Pass Overall Compliance: No Severity Score: 26

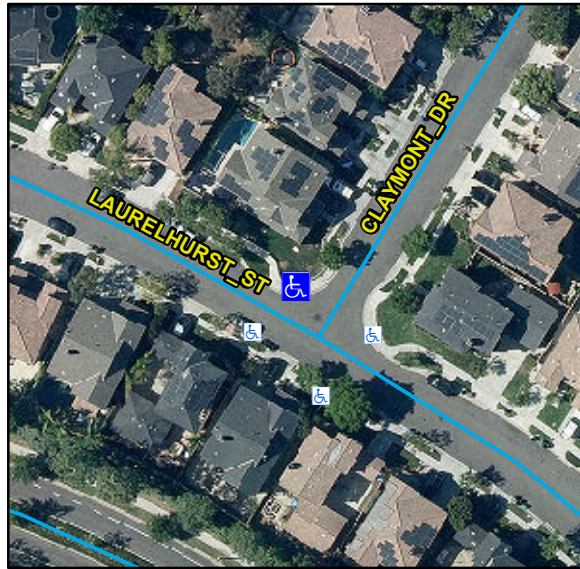
| Compliance | Description | Data | Compliance | Description | Data |
|---|---|---|---|---|---|
| Yes | Gutter Ponding | No | No | Curb Slope | 13.3 |
| No | Gutter Run Slope (%) | 7.8 | | Road Cross Slope (%) | 3.8 |
| Yes | Gutter Cross Slope (%) | 1.3 | No | Perpendicular Joint Present | No |

Remove & Replace Curb Ramp With Two New Directional Ramps or Equivalent. Remove & Replace Gutter.
