# Access Compliance Report Public Rights-of-Way (Curb Ramps)

| Main Street: CLAYMONT_DR | Cross Street: LAURELHURST_ST | Location: E |

| ADA ID: RPRK211020175557 | Ramp Type: Type 4 - Parallel | Initial Pass/Fail: Fail | Overall Compliance: No | Severity Score: 2 |

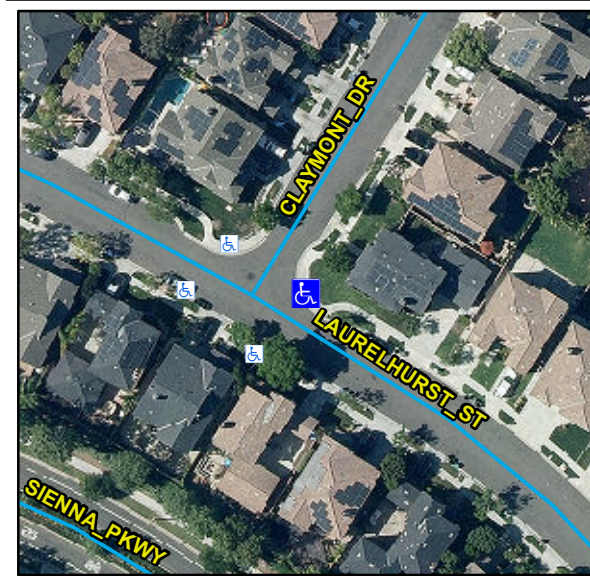
**R204.3, R304.5.3, STD 1115**

| Compliance | Description | Data | Compliance | Description | Data |
|---|---|---|---|---|---|
| No | Ramp Cross Slope LT (%) | 2.6 | No | Ramp Cross Slope RT (%) | 2.8 |

**Remove & Replace Curb Ramp With Two New Directional Ramps or Equivalent.**

Total Cost: \$ 4000
