# Access Compliance Report Public Rights-of-Way (Curb Ramps)

| Main Street: N/A | | Cross Street: OSO_PKWY | | Location: | E |
| ADA ID: RPRK211021113656 | Ramp Type: Type 1 - Perpendicular | Initial Pass/Fail: Pass | Overall Compliance: No | Severity Score: | 0 |

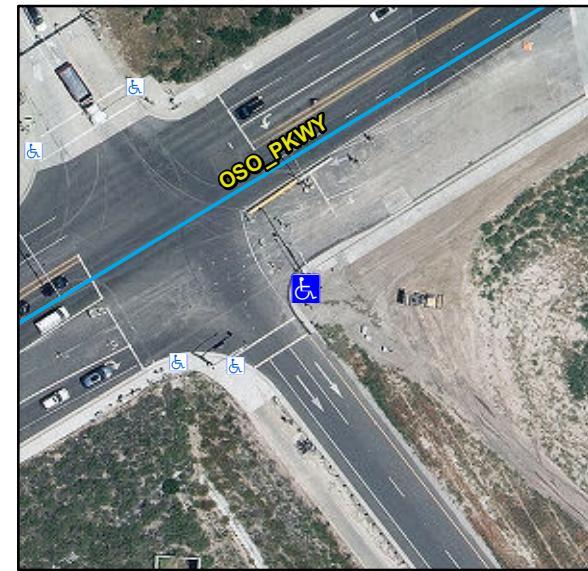
| Compliance | Description | Data | Compliance | Description | Data |
|---|---|---|---|---|---|
| Yes | Gutter Ponding | No | No | Curb Slope | 6 |

Possible Solutions:

**Remove & Replace Curb Slope.**

**R304.2.2, STD 1115**

Total Cost: \$ 252
