# Access Compliance Report Public Rights-of-Way (Curb Ramps)

| Main Street: LOS PATRONES PKWY | | Cross Street: OSO PKWY | | Location: | SW |
| ADA ID: RPRK211021114301 | Ramp Type: Type 1 - Perpendicular | Initial Pass/Fail: Pass | Overall Compliance: No | Severity Score: | 2 |

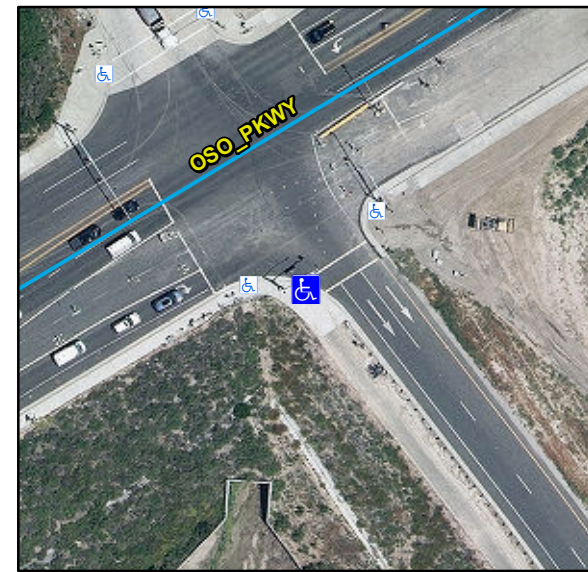
| Compliance | Description | Data | Compliance | Description | Data |
|---|---|---|---|---|---|
| Yes | Gutter Ponding | No | No | Curb Slope | 7.3 |

**Remove & Replace Curb Slope.**

**R304.2.2, STD 1115**

Total Cost: \$ 252
