# Access Compliance Report Public Rights-of-Way (Curb Ramps)

Main Street: N/A Cross Street: OSO\_PKWY Location: NW

ADA ID: RPRK211021120506 Ramp Type: Type 1 - Perpendicular Initial Pass/Fail: Pass Overall Compliance: No Severity Score: 5

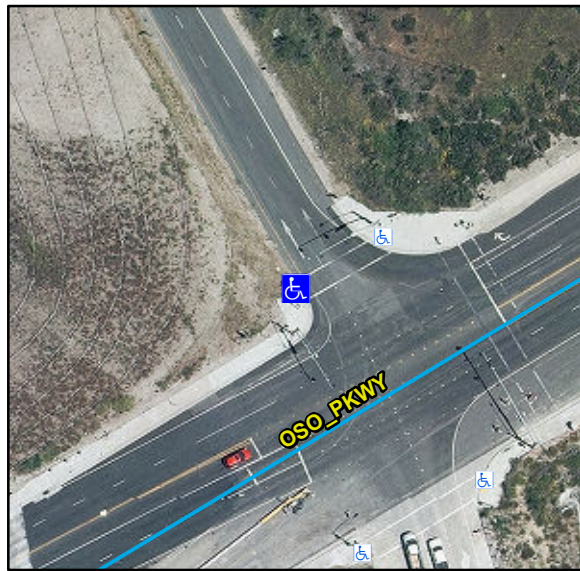
| Compliance | Description | Data | Compliance | Description | Data |
|---|---|---|---|---|---|
| Yes | Gutter Ponding | No | No | Curb Slope | 6.4 |
| No | Gutter Run Slope (%) | 5.4 | | Road Cross Slope (%) | N/A |

Remove & Replace Curb Slope. Remove & Replace Gutter.
