# Access Compliance Report Public Rights-of-Way (Curb Ramps)

Main Street: **OSO\_PKWY** Cross Street: **LOS\_PATRONES\_PKWY** Location: **SE**

ADA ID: **RPRK211021121351** Ramp Type: **Type 1 - Perpendicular Diagonal** Initial Pass/Fail: **Pass** Overall Compliance: **No** Severity Score: **2**

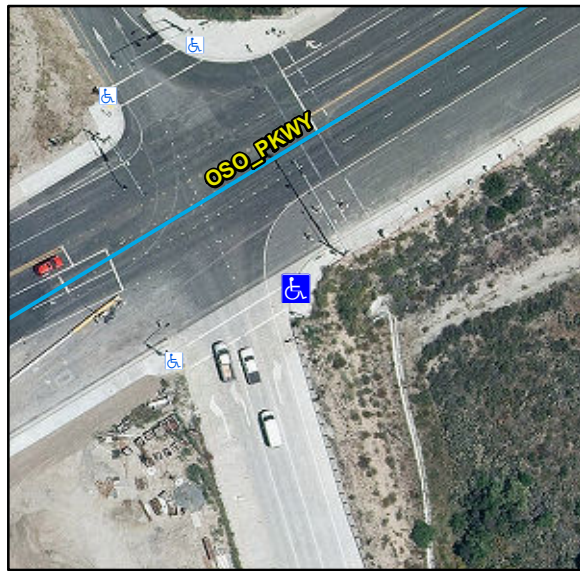
| Compliance | Description | Data | Compliance | Description | Data |
|---|---|---|---|---|---|
| No | Ramp Cross Slope (%) | 2.5 | N/A | Flare Traversable LT | Yes |

**Remove & Replace Curb Ramp With Two New Directional Ramps or Equivalent.**

**R304.5.3, STD 1115**
