# Access Compliance Report Public Rights-of-Way (Curb Ramps)

| Main Street: LOS PATRONES PKWY | | Cross Street: OSO PKWY | | Location: | S |
| ADA ID: RPRK211021121753 | Ramp Type:Type 1 - Perpendicular | Initial Pass/Fail: Pass | Overall Compliance: No | Severity Score: | 16 |

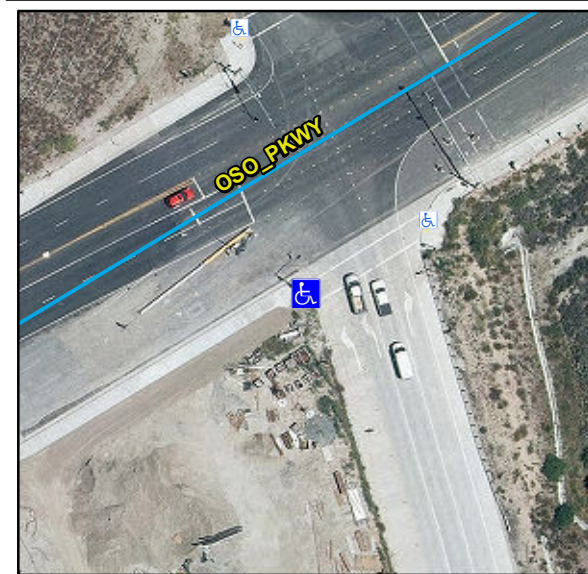
| Compliance | Description | Data | Compliance | Description | Data |
|---|---|---|---|---|---|
| No | Landing Width (in) | N/A | Yes | Flare Slope RT (%) | 9.4 |
| No | Landing Run Slope (%) | N/A | N/A | Flare Traversable RT | Yes |
| No | Landing Cross Slope (%) | N/A | Yes | DWS Provided | Yes |
| Yes | Gutter Ponding | No | No | Curb Slope | 5.5 |
| No | Gutter Run Slope (%) | 5.9 | | Road Cross Slope (%) | N/A |

**Remove & Replace Entire Ramp. Remove & Replace Gutter.**

**R304.2.2, R304.2.1, R304.2.2-Perp, R304.3.2-Para, R304.5.3, R304.5.4, STD 1115**
