# Access Compliance Report Public Rights-of-Way (Curb Ramps)

| Main Street: MORNING_TRAIL | | Cross Street: ACANTHUS | | Location: | SW |
| ADA ID: RPRK211021122927 | Ramp Type: Type 4 - Parallel | Initial Pass/Fail: Fail | Overall Compliance: No | Severity Score: | 30 |

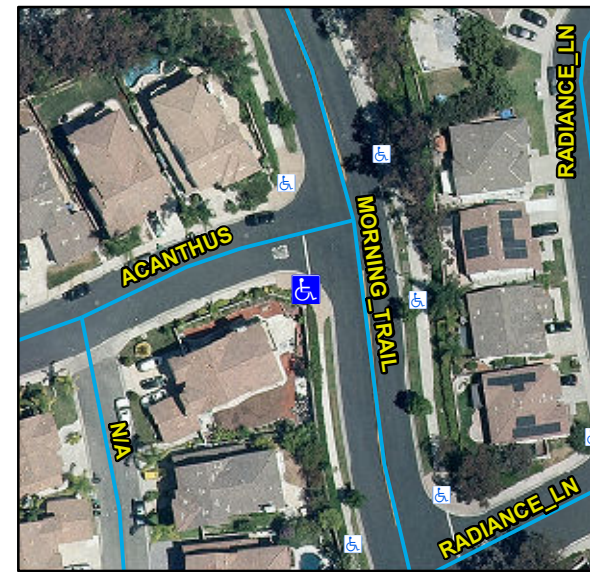
| Compliance | Description | Data | Compliance | Description | Data |
|---|---|---|---|---|---|
| No | Ramp Cross Slope LT (%) | 7.6 | No | Ramp Cross Slope RT (%) | 8.7 |

**Remove & Replace Curb Ramp With Two New Directional Ramps or Equivalent.**

**R204.3, R304.5.3, STD 1115**
