# Access Compliance Report Public Rights-of-Way (Curb Ramps)

Main Street: **OSO\_PKWY** Cross Street: **MORNING\_TRAIL** Location: **SE**

ADA ID: **RPRK211021124247** Ramp Type: **Type 1 - Perpendicular Diagonal Initial Pass/Fail: Fail** Overall Compliance: **No** Severity Score: **16**

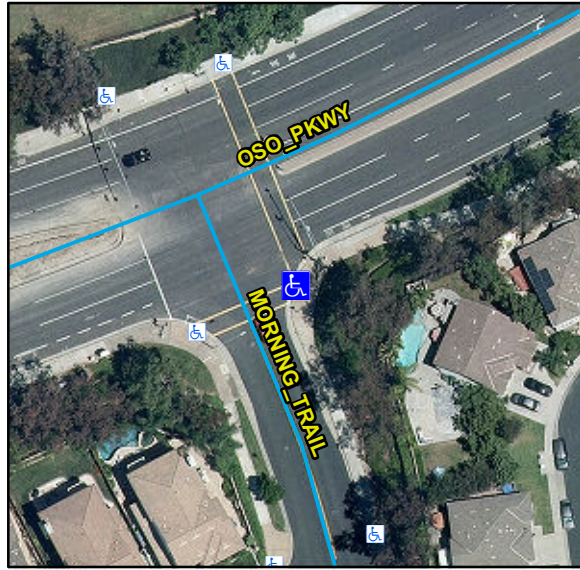
| Compliance | Description | Data | Compliance | Description | Data |
|---|---|---|---|---|---|
| <b>No</b> | Ramp Run Slope (%) | <b>11.4</b> | <b>N/A</b> | Flare Slope LT (%) | <b>N/A</b> |
| <b>No</b> | Ramp Cross Slope (%) | <b>2.6</b> | <b>N/A</b> | Flare Traversable LT | <b>N/A</b> |
| <b>N/A</b> | Gutter Ponding | <b>N/A</b> | <b>No</b> | Curb Slope | <b>8.7</b> |

**Remove & Replace Curb Ramp With Two New Directional Ramps or Equivalent.**

**R304.2.2, R204.3, R304.5.3, STD 1115**
