# Access Compliance Report Public Rights-of-Way (Curb Ramps)

| Main Street: HALF_MOON_TRAIL | | Cross Street: IRON_HORSE_TRAIL | | Location: | S |
| ADA ID: RPRK211021131442 | Ramp Type: Type 4 - Parallel | Initial Pass/Fail: Fail | Overall Compliance: No | Severity Score: | 16 |

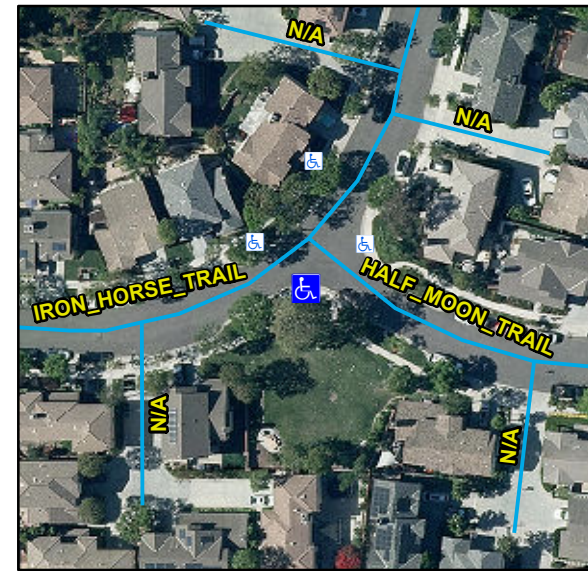
| Compliance | Description | Data | Compliance | Description | Data |
|---|---|---|---|---|---|
| Yes | Ramp Run Slope LT (%) | 4.1 | No | Ramp Run Slope RT (%) | 9.9 |
| No | Ramp Cross Slope LT (%) | 2.9 | Yes | Ramp Cross Slope RT (%) | 1.9 |

**Remove & Replace Curb Ramp With Two New Directional Ramps or Equivalent.**

**R304.5.3, R304.3.2, STD 1115**
