# Access Compliance Report Public Rights-of-Way (Curb Ramps)

| Main Street: IRON_HORSE_TRAIL | | Cross Street: HALF_MOON_TRAIL | | Location: | E |
| ADA ID: RPRK211021131648 | Ramp Type: Type 4 - Parallel | Initial Pass/Fail: Fail | Overall Compliance: No | Severity Score: | 15 |

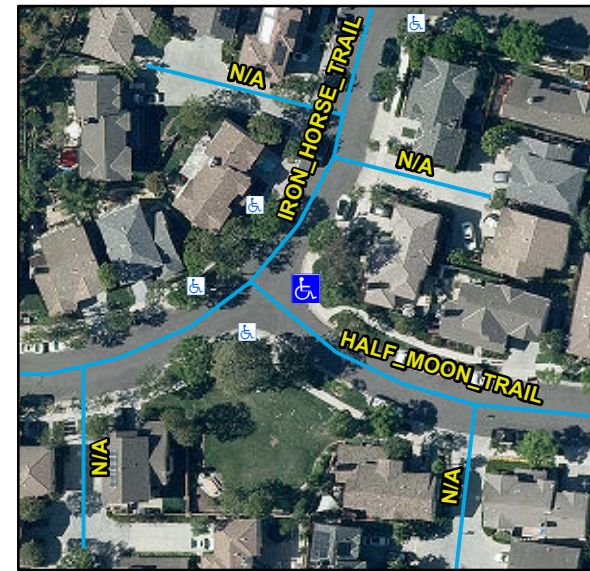
| Compliance | Description | Data | Compliance | Description | Data |
|---|---|---|---|---|---|
| Yes | Ramp Run Slope LT (%) | 3.2 | No | Ramp Run Slope RT (%) | 10.3 |

**Remove & Replace Curb Ramp With Two New Directional Ramps or Equivalent.**

**R304.3.2, STD 1115**

Total Cost: \$ 4000
