# Access Compliance Report Public Rights-of-Way (Curb Ramps)

| Main Street: HALF_MOON_TRAIL | | Cross Street: IRON_HORSE_TRAIL | | Location: | S |
| ADA ID: RPRK211021131958 | Ramp Type: Type 4 - Parallel | Initial Pass/Fail: Fail | Overall Compliance: No | Severity Score: | 16 |

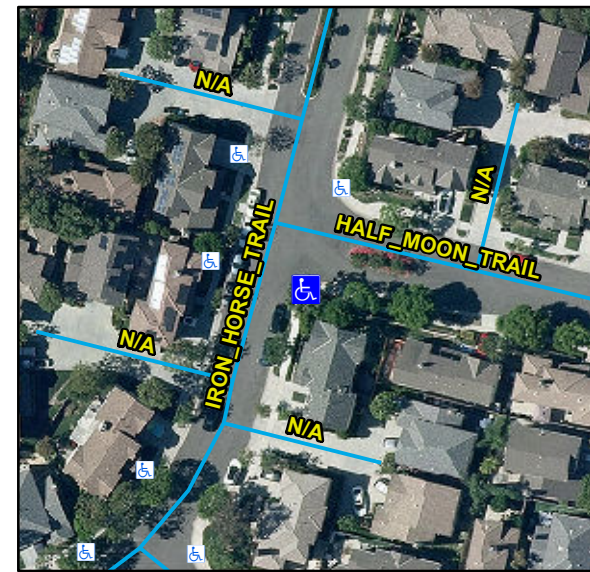
| Compliance | Description | Data | Compliance | Description | Data |
|---|---|---|---|---|---|
| Yes | Ramp Run Slope LT (%) | 3.2 | No | Ramp Run Slope RT (%) | 8.6 |

Remove & Replace Curb Ramp With Two New Directional Ramps or Equivalent.

R204.3, R304.3.2, STD 1115
