# Access Compliance Report Public Rights-of-Way (Curb Ramps)

Main Street: SIENNA\_PKWY Cross Street: IRON\_HORSE\_TRAIL Location: S

ADA ID: RPRK211021132405 Ramp Type: Type 1 - Perpendicular Diagonal Initial Pass/Fail: Fail Overall Compliance: No Severity Score: 16

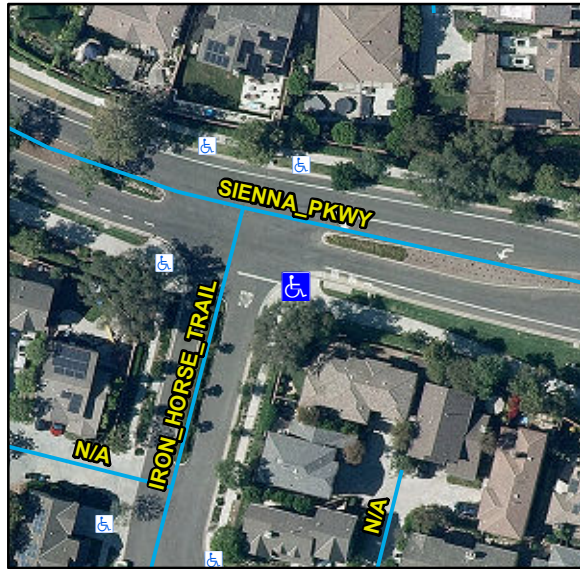
| Compliance | Description | Data | Compliance | Description | Data |
|---|---|---|---|---|---|
| No | Ramp Run Slope (%) | 9.1 | N/A | Flare Slope LT (%) | N/A |
| No | Ramp Cross Slope (%) | 3.8 | N/A | Flare Traversable LT | N/A |

Remove & Replace Curb Ramp With Two New Directional Ramps or Equivalent.

R304.2.2, R204.3, R304.5.3, STD 1115
