# Access Compliance Report Public Rights-of-Way (Curb Ramps)

Main Street: IRON\_HORSE\_TRAIL Cross Street: SIENNA\_PKWY Location: SW

ADA ID: RPRK211021132613 Ramp Type: Type 1 - Perpendicular Diagonal Initial Pass/Fail: Fail Overall Compliance: No Severity Score: 2

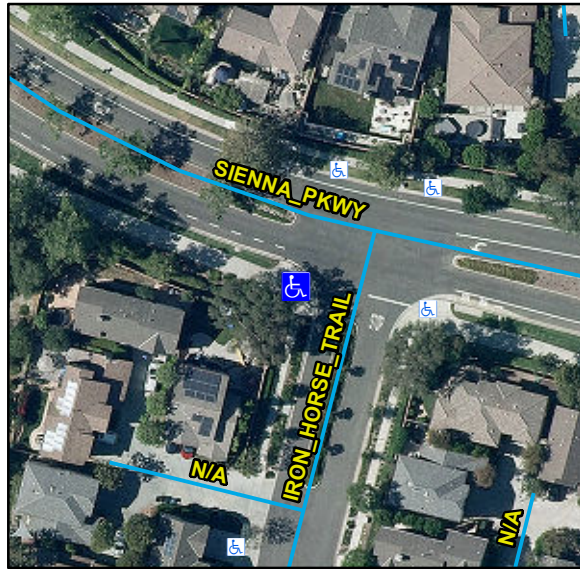
| Compliance | Description | Data | Compliance | Description | Data |
|---|---|---|---|---|---|
| No | Ramp Cross Slope (%) | 2.9 | N/A | Flare Traversable LT | N/A |
| N/A | Gutter Ponding | N/A | No | Curb Slope | 11.2 |

Remove & Replace Curb Ramp With Two New Directional Ramps or Equivalent.

R304.2.2, R204.3, R304.5.3, STD 1115
