# Access Compliance Report Public Rights-of-Way (Curb Ramps)

Main Street: SIENNA\_PKWY Cross Street: SLEEPY\_HOLLOW\_LN Location: NW

ADA ID: RPRK211021132912 Ramp Type: Type 1 - Perpendicular Diagonal Initial Pass/Fail: Fail Overall Compliance: No Severity Score: 2

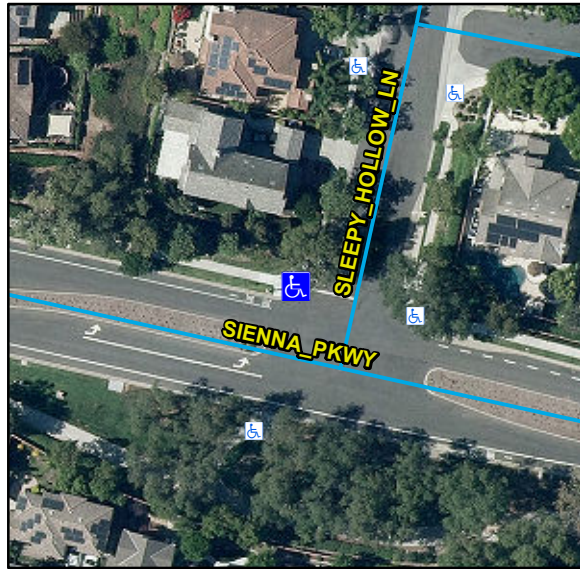
| Compliance | Description | Data | Compliance | Description | Data |
|---|---|---|---|---|---|
| No | Ramp Cross Slope (%) | 2.3 | N/A | Flare Traversable LT | N/A |

Remove & Replace Curb Ramp With Two New Directional Ramps or Equivalent.
