# Access Compliance Report Public Rights-of-Way (Curb Ramps)

Main Street: SLEEPY\_HOLLOW\_LN Cross Street: MAYVILLE\_PL Location: NE

ADA ID: RPRK211021133641 Ramp Type: Type 4 - Parallel Initial Pass/Fail: Pass Overall Compliance: No Severity Score: 20

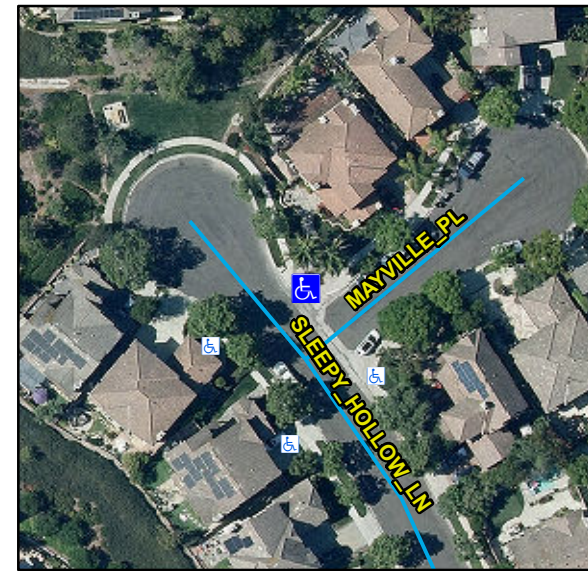
## Field Measurements/Component Compliance

| Compliance | Description | Data | Compliance | Description | Data |
|---|---|---|---|---|---|
| N/A | Landing Present | No | No | DWS Provided | No |
| No | Landing Width (in) | N/A | N/A | DWS Length (in) | N/A |
| No | Landing Run Slope (%) | N/A | N/A | DWS Full Width | N/A |
| No | Landing Cross Slope (%) | N/A | | DWS Offset Type | N/A |

Remove & Replace Curb Ramp With Two New Directional Ramps or Equivalent.

R204.3, R304.2.1, R304.2.2-Perp, R304.3.2-Para, R304.5.3, R305, STD 1115

Total Cost: \$ 4000
