# Access Compliance Report Public Rights-of-Way (Curb Ramps)

Main Street: MAYVILLE\_PL Cross Street: SLEEPY\_HOLLOW\_LN Location: SE

ADA ID: RPRK211021133857 Ramp Type: Type 4 - Parallel Initial Pass/Fail: Fail Overall Compliance: No Severity Score: 2

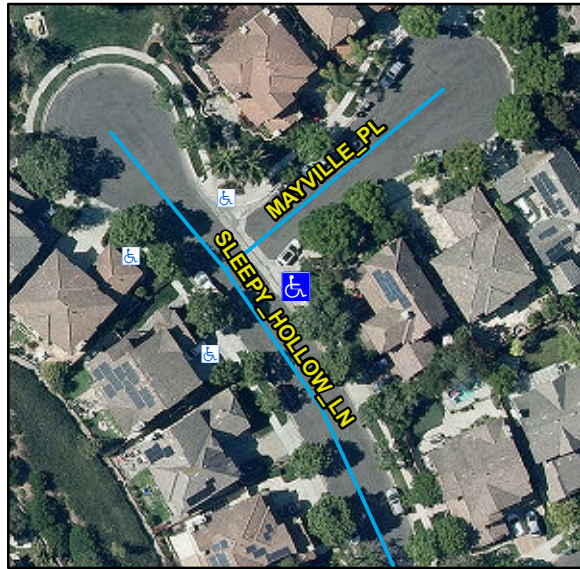
| Compliance | Description | Data | Compliance | Description | Data |
|---|---|---|---|---|---|
| Yes | Ramp Cross Slope LT (%) | 1 | No | Ramp Cross Slope RT (%) | 2.7 |

Remove & Replace Curb Ramp With Two New Directional Ramps or Equivalent.

R304.5.3, STD 1115
