# Access Compliance Report Public Rights-of-Way (Curb Ramps)

Main Street: SLEEPY\_HOLLOW\_LN Cross Street: SOMMERVILLE\_PL Location: NE

ADA ID: RPRK211021134051 Ramp Type: Type 4 - Parallel Initial Pass/Fail: Fail Overall Compliance: No Severity Score: 2

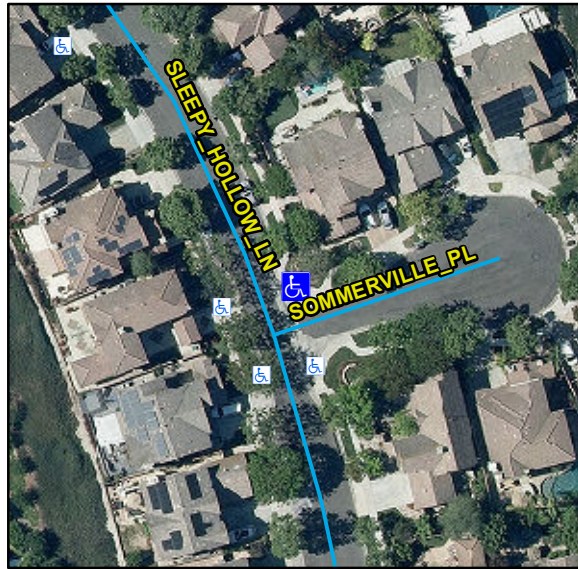
| Compliance | Description | Data | Compliance | Description | Data |
|---|---|---|---|---|---|
| Yes | Ramp Cross Slope LT (%) | 1.5 | No | Ramp Cross Slope RT (%) | 2.9 |

**Remove & Replace Curb Ramp With Two New Directional Ramps or Equivalent.**

**R204.3, R304.5.3, STD 1115**
