# Access Compliance Report Public Rights-of-Way (Curb Ramps)

Main Street: SOMMERVILLE\_PL Cross Street: SLEEPY\_HOLLOW\_LN Location: SE

ADA ID: RPRK211021134342 Ramp Type: Type 4 - Parallel Initial Pass/Fail: Fail Overall Compliance: No Severity Score: 15

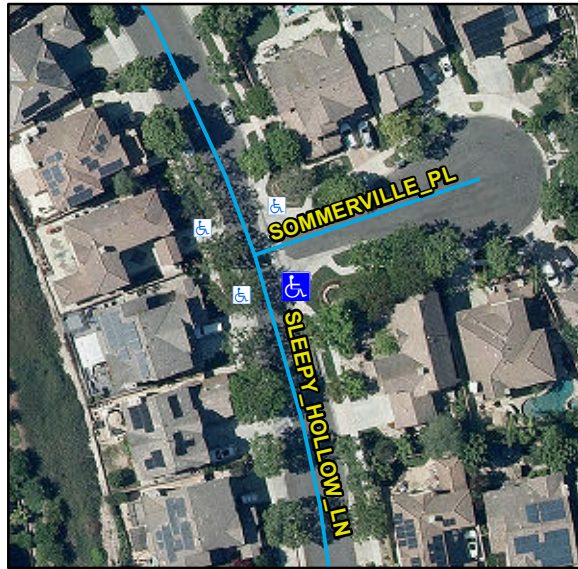
| Compliance | Description | Data | Compliance | Description | Data |
|---|---|---|---|---|---|
| No | Ramp Run Slope LT (%) | 8.7 | Yes | Ramp Run Slope RT (%) | 2.6 |

**Remove & Replace Curb Ramp With Two New Directional Ramps or Equivalent.**

**R204.3, R304.3.2, STD 1115**
