# Access Compliance Report Public Rights-of-Way (Curb Ramps)

Main Street: SLEEPY\_HOLLOW\_LN Cross Street: VINEWOOD\_LN Location: NE

ADA ID: RPRK211021134557 Ramp Type: Type 4 - Parallel Initial Pass/Fail: Pass Overall Compliance: No Severity Score: 20

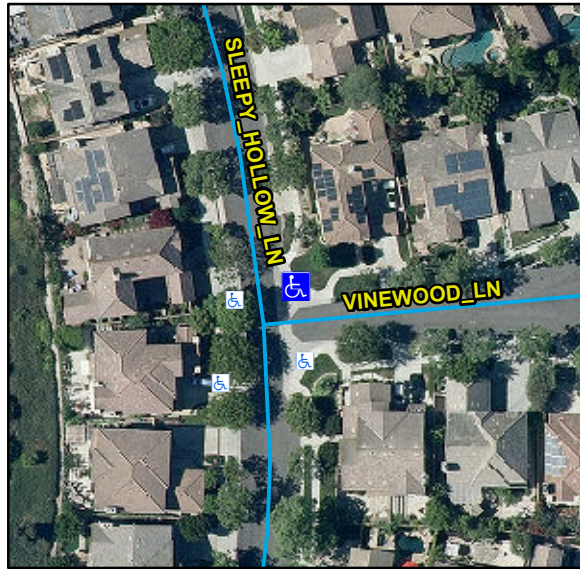
R204.3, R304.2.1, R304.2.2-Perp, R304.3.2-Para, R304.5.3, R305, STD 1115

| Compliance | Description | Data | Compliance | Description | Data |
|---|---|---|---|---|---|
| N/A | Landing Present | No | No | DWS Provided | No |
| No | Landing Width (in) | N/A | N/A | DWS Length (in) | N/A |
| No | Landing Run Slope (%) | N/A | N/A | DWS Full Width | N/A |
| No | Landing Cross Slope (%) | N/A | | DWS Offset Type | N/A |

Remove & Replace Curb Ramp With Two New Directional Ramps or Equivalent.
