# Access Compliance Report Public Rights-of-Way (Curb Ramps)

Main Street: SLEEPY\_HOLLOW\_LN Cross Street: LONE\_OAK\_CIR Location: NE

ADA ID: RPRK211021135102 Ramp Type: Type 4 - Parallel Initial Pass/Fail: Fail Overall Compliance: No Severity Score: 2

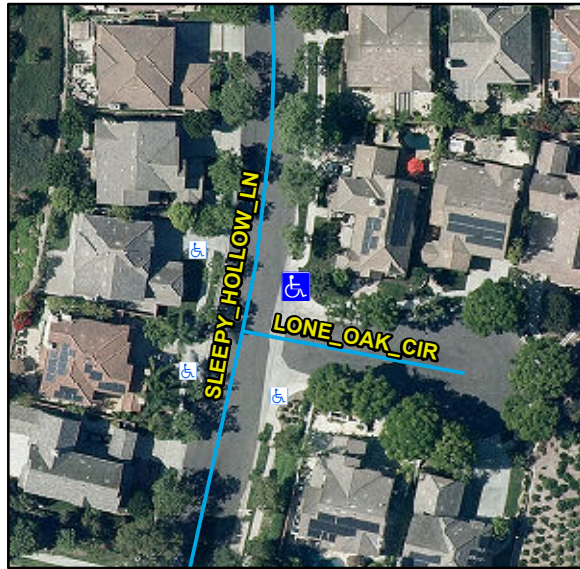
| Compliance | Description | Data | Compliance | Description | Data |
|---|---|---|---|---|---|
| Yes | Ramp Cross Slope LT (%) | 0.2 | No | Ramp Cross Slope RT (%) | 2.6 |

**Remove & Replace Curb Ramp With Two New Directional Ramps or Equivalent.**

**R304.5.3, STD 1115**
