# Access Compliance Report Public Rights-of-Way (Curb Ramps)

Main Street: LONE\_OAK\_CIR Cross Street: SLEEPY\_HOLLOW\_LN Location: S

ADA ID: RPRK211021135340 Ramp Type: Type 4 - Parallel Initial Pass/Fail: Fail Overall Compliance: No Severity Score: 15

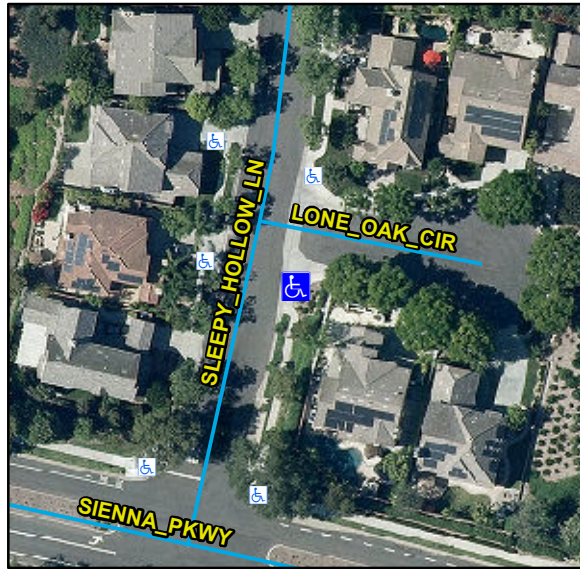
| Compliance | Description | Data | Compliance | Description | Data |
|---|---|---|---|---|---|
| No | Ramp Run Slope LT (%) | 11.1 | Yes | Ramp Run Slope RT (%) | 0.3 |

Remove & Replace Curb Ramp With Two New Directional Ramps or Equivalent.

R204.3, R304.3.2, STD 1115
