# Access Compliance Report Public Rights-of-Way (Curb Ramps)

Main Street: SLEEPY\_HOLLOW\_LN Cross Street: SIENNA\_PKWY Location: E

ADA ID: RPRK211021135549 Ramp Type: Type 1 - Perpendicular Diagonal Initial Pass/Fail: Fail Overall Compliance: No Severity Score: 2

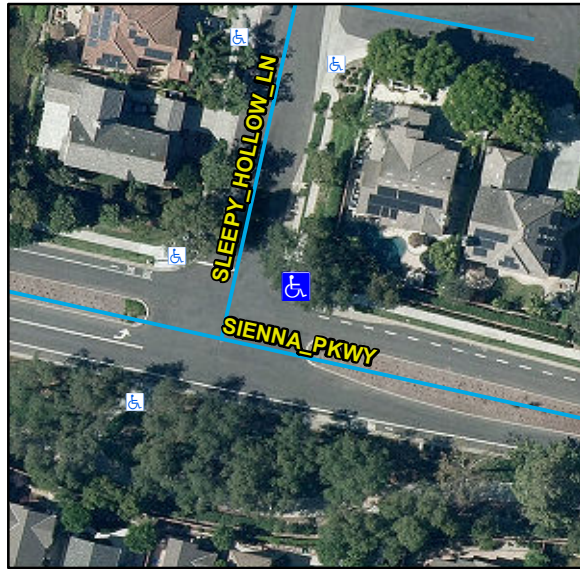
| Compliance | Description | Data | Compliance | Description | Data |
|---|---|---|---|---|---|
| No | Ramp Cross Slope (%) | 2.8 | N/A | Flare Traversable LT | N/A |

**Remove & Replace Curb Ramp With Two New Directional Ramps or Equivalent.**

**R304.2.2, R304.5.3, STD 1115**
