# Access Compliance Report Public Rights-of-Way (Curb Ramps)

| Main Street: SIENNA_PKWY | | Cross Street: SLEEPY_HOLLOW_LN | | Location: | SW |
| ADA ID: RPRK211021135817 | Ramp Type: Type 1 - Perpendicular | Initial Pass/Fail: Fail | Overall Compliance: No | Severity Score: | 16 |

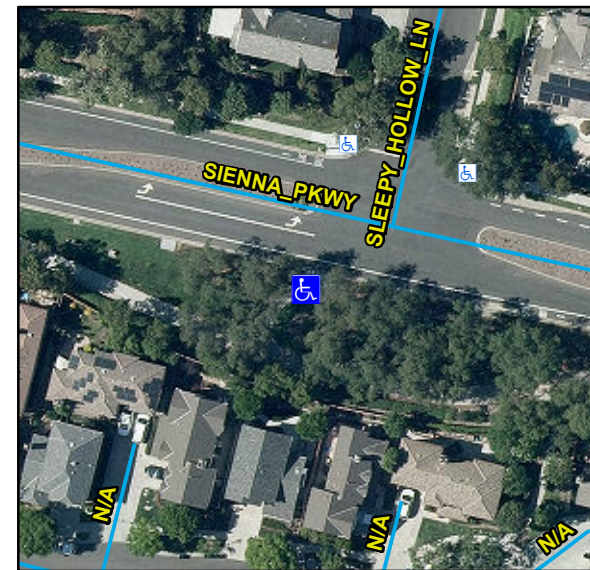
| Compliance | Description | Data | Compliance | Description | Data |
|---|---|---|---|---|---|
| No | Ramp Run Slope (%) | 8.5 | N/A | Flare Slope LT (%) | N/A |
| No | Ramp Cross Slope (%) | 3.1 | N/A | Flare Traversable LT | N/A |

Possible Solutions:

Remove & Replace Entire Ramp.

R204.3, R304.2.2, R304.5.3, STD 1115
