# Access Compliance Report Public Rights-of-Way (Curb Ramps)

Main Street: SKYWOOD\_ST Cross Street: SKYWOOD\_ST Location: E

ADA ID: RPRK211021141817 Ramp Type: Type 4 - Parallel Initial Pass/Fail: Fail Overall Compliance: No Severity Score: 30

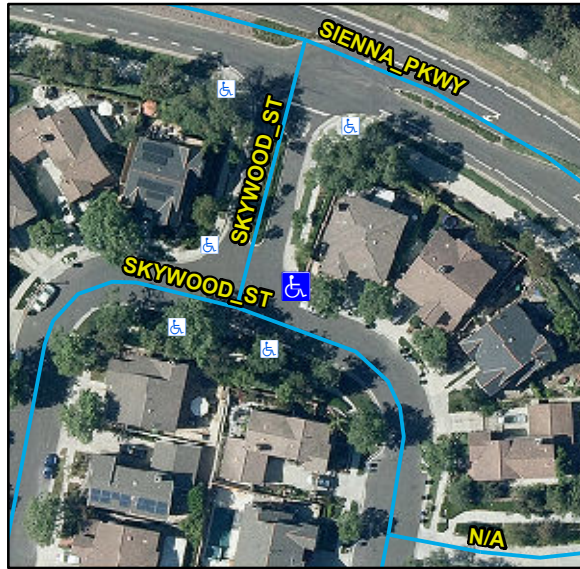
| Compliance | Description | Data | Compliance | Description | Data |
|---|---|---|---|---|---|
| Yes | Ramp Run Slope LT (%) | 2.5 | No | Ramp Run Slope RT (%) | 12.2 |

Remove & Replace Curb Ramp With Two New Directional Ramps or Equivalent.

R304.3.2, STD 1115
