# Access Compliance Report Public Rights-of-Way (Curb Ramps)

Main Street: SKYWOOD\_ST Cross Street: SKYWOOD\_ST Location: N

ADA ID: RPRK211021142003 Ramp Type: Type 4 - Parallel Initial Pass/Fail: Fail Overall Compliance: No Severity Score: 15

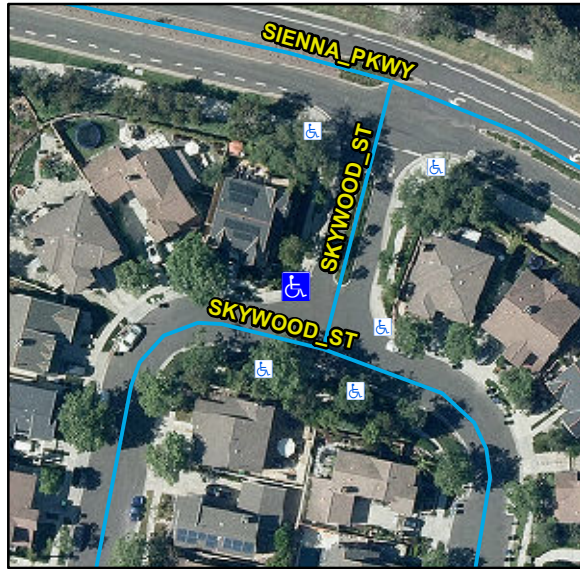
| Compliance | Description | Data | Compliance | Description | Data |
|---|---|---|---|---|---|
| No | Ramp Run Slope LT (%) | 11.5 | Yes | Ramp Run Slope RT (%) | 3.6 |

Remove & Replace Curb Ramp With Two New Directional Ramps or Equivalent.

R304.3.2, STD 1115
