# Access Compliance Report Public Rights-of-Way (Curb Ramps)

Main Street: SKYWOOD\_ST Cross Street: SIENNA\_PKWY Location: W

ADA ID: RPRK211021142208 Ramp Type: Type 1 - Perpendicular Diagonal Initial Pass/Fail: Pass Overall Compliance: No Severity Score: 21

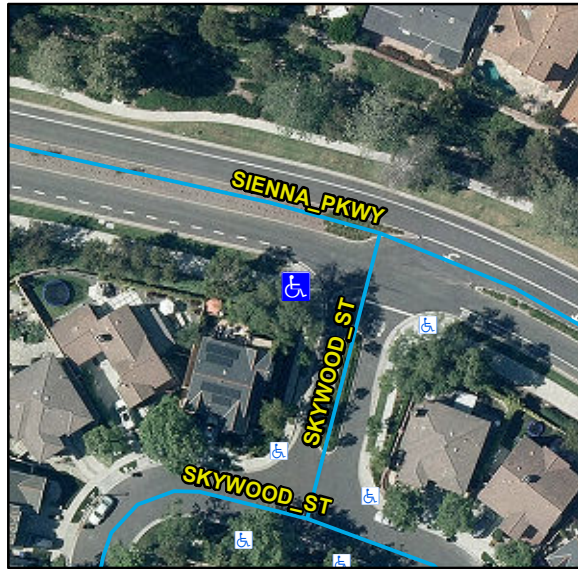
| Compliance | Description | Data | Compliance | Description | Data |
|---|---|---|---|---|---|
| Yes | Landing Cross Slope (%) | 1.7 | No | DWS Provided | No |
| No | Gutter Run Slope (%) | 9 | | Road Cross Slope (%) | 5.8 |

**Remove & Replace Curb Ramp With Two New Directional Ramps or Equivalent. Remove & Replace Gutter.**

**R204.3, R304.2.1, R305, R304.5.4, STD 1115**
