# Access Compliance Report Public Rights-of-Way (Curb Ramps)

Main Street: SIENNA\_PKWY Cross Street: BLAKEMORE\_DR Location: SW

ADA ID: RPRK211021142916 Ramp Type: Type 1 - Perpendicular Initial Pass/Fail: Fail Overall Compliance: No Severity Score: 15

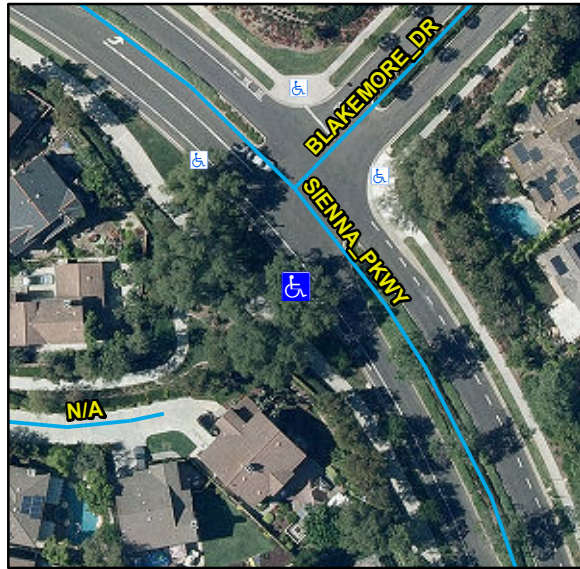
| Compliance | Description | Data | Compliance | Description | Data |
|---|---|---|---|---|---|
| No | Ramp Run Slope (%) | 8.9 | N/A | Flare Slope LT (%) | N/A |
| N/A | Gutter Ponding | N/A | No | Curb Slope | 17.1 |

Remove & Replace Entire Ramp.

R304.2.2, R204.3, STD 1115
