# Access Compliance Report Public Rights-of-Way (Curb Ramps)

Main Street: SIENNA\_PKWY Cross Street: BLAKEMORE\_DR Location: NE

ADA ID: RPRK211021143428 Ramp Type: Type 1 - Perpendicular Diagonal Initial Pass/Fail: Pass Overall Compliance: No Severity Score: 14

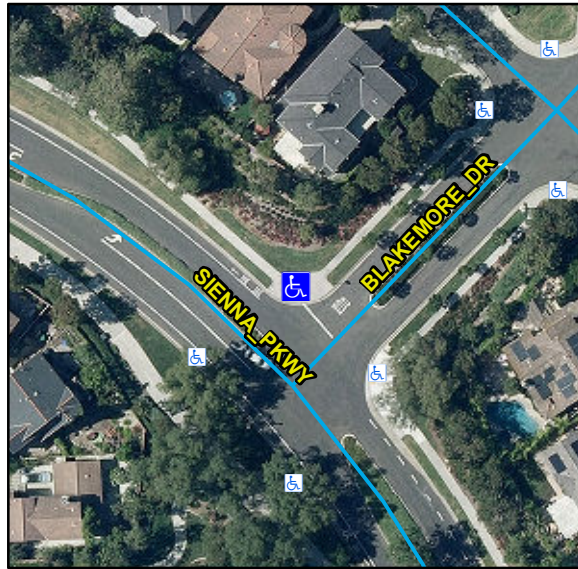
| Compliance | Description | Data | Compliance | Description | Data |
|---|---|---|---|---|---|
| No | Landing Run Slope (%) | 2.4 | N/A | Flare Traversable RT | Yes |
| No | Landing Cross Slope (%) | 3.1 | No | DWS Provided | No |
| Yes | Gutter Ponding | No | No | Curb Slope | 6.6 |

Remove & Replace Curb Ramp With Two New Directional Ramps or Equivalent.
